## Sample Planned Development

### Reserve Study Report Reserve Study With Site Visit

**For 30-Year Projection Period Beginning 01/01/11**

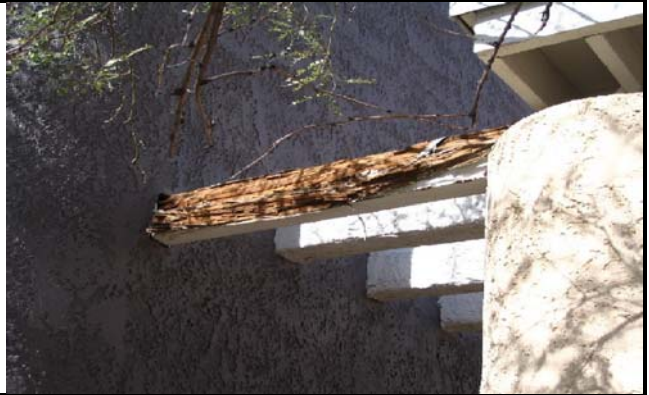
**Dry rot in non structural wooden beam** - This beam connecting a column to the wall does not serve a structural purpose and is only present for aesthetic reasons. Due to the extensive dry rot we recommend that this beam be immediately replaced or removed. Also see comment below regarding other stucco-wrapped beams that are part of the same structure.

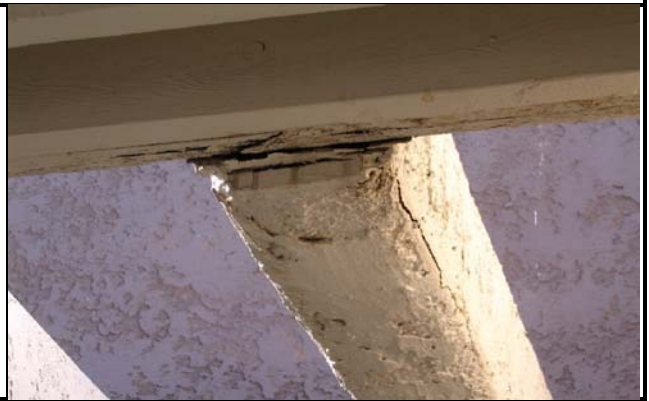
**Dry rot affecting roofing support structure at pool area ramada roof** - The stucco-wrapped aesthetic beams are a design deficiency as they serve no structural purpose, and are compromising the structural soundness of the attached roofing structure. As seen in this photo, the beams are trapping water at the joints, which is causing dry rot not only in the beam, but also in the roofing support beams of the ramada roof structure.

The large crack in the stucco also indicates that the wood within the stucco has absorbed water and greatly expanded, causing the stucco to crack. Without repair, this beam, and others with similar damage will eventually fall off, creating a safety hazard for Association residents. We recommend that the beams be removed, both as a safety measure, and as a means of minimizing dry rot damage to roof support beams.
